## NON-DESTRUCTIVE TESTING METHODS FOR EXAMINATION OF FAILED PLASTIC PARTS

Eric A. Beebe, E.I.T., Kevin W. Hollander, Ph.D., David S. Komm, P.E. and Todd A. Springer, E.I.T.  
Augsburger Komm Engineering, Inc.

### Abstract

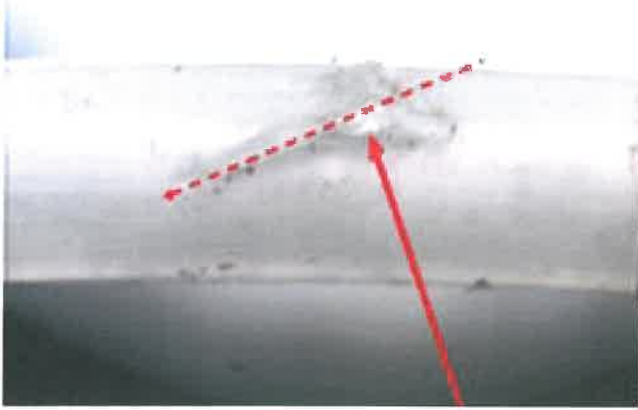
Figure 1: View of compromised section of tubing

A visual examination of a failed polypropylene water line revealed multiple locations with adhesive residue, as well as a number of surface abrasions and cuts. However, a microscopic evaluation, utilizing backlighting techniques identified specific features that led to the determination of the cause of failure. Figure 1 provides a view of the compromised portion of tubing discovered during this examination.

In Figure 1, the solid arrow indicates the point of breach and the thin dashed arrow denotes the probable direction of the puncture that caused an uncontrolled release of water.

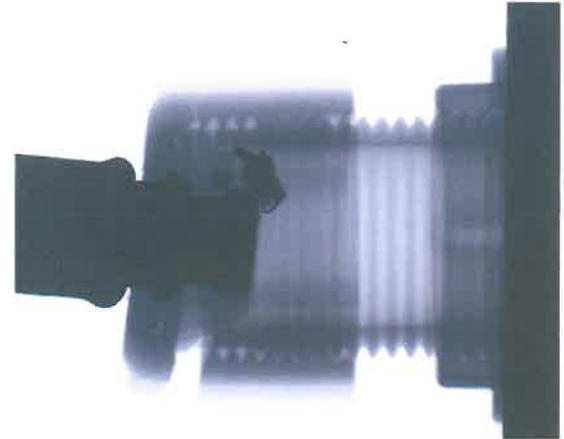
Figure 2: X-ray image of the subject nut

Figure 2, shows the internal threading of the nut and the corresponding external threads of the ball cock valve. Immediately apparent is the presence of some foreign material on the surface of the rubber grommet. Due to the similarity of light porosity shown on the X-ray, it is expected that the density of the foreign material is only slightly less than that of the neighboring metal insert, shown on the left hand side of Figure 2. Nevertheless, this foreign substance is not likely related to the crack failure, since it does not contribute to stresses on the subject nut.

The view of the crack from this image, Figure 2, shows that it lies in the valley of the last internal thread of the nut, located near the base of the grommet. This can be observed at the bottom portion of the image as well as at the top. In addition, the X-ray photos provide information about the depth of insertion of the male pipe into the fractured nut. Since this point of failure has not been moved, this view would indicate the depth achieved at the time of installation, which can be quantified.

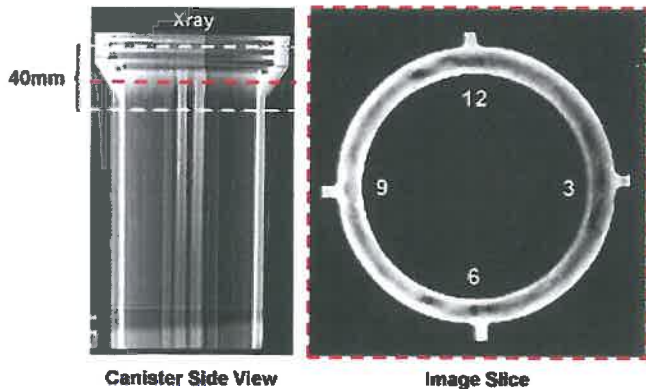
Figure 5: CAT scan images of failed filter.

R.O. systems are commonly used to treat household drinking water. These systems usually have several plastic canisters in series, purifying the incoming water. R.O. system canisters have been known to fail in the region indicated by the red dashed line in Figure 5.

CAT scanning was used to capture images of the upper portion of three canisters taken from a R.O. system, one of which had failed. Data was captured at a resolution of 2mm per slice, and a cross section can be seen in Figure 5.

The image on the left side of Figure 5 is an X-ray profile view of the failed canister. The section above the white dashed lines indicates the scanned region of the part. Looking closely at this image, it can be seen that the fracture is located just above the red dashed line.

The image on the right side of Figure 5 provides an image from the CAT scan data. The image shown corresponds to the red dashed line visible on the X-ray profile image. The CAT scan data revealed the part to be solid through its cross-section. However, the image did show a number of variations within the material.

Some variations are partially due to geometry changes in the part. However, due to the symmetry of the part, the majority of these variations can be attributed to changes in material density. All three canisters were scanned and demonstrated similar variations in material density, although the magnitude of density change for each is not known.

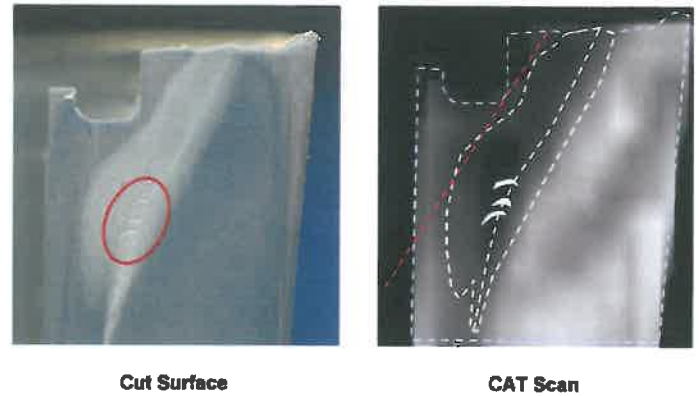
Figure 6: CAT scan edge view comparison: subject pre-filter canister.

Using the CAT scan information as a guide, the upper portion of each of the canisters was sectioned into quarters. One of the exposed cross-sections can be seen in Figure 6.

As seen in Figure 6, destructive testing confirmed the location of low density regions within the material as well as the location of a number of voids that had formed. The formation of voids and low density regions are directly related to the manufacturing process.

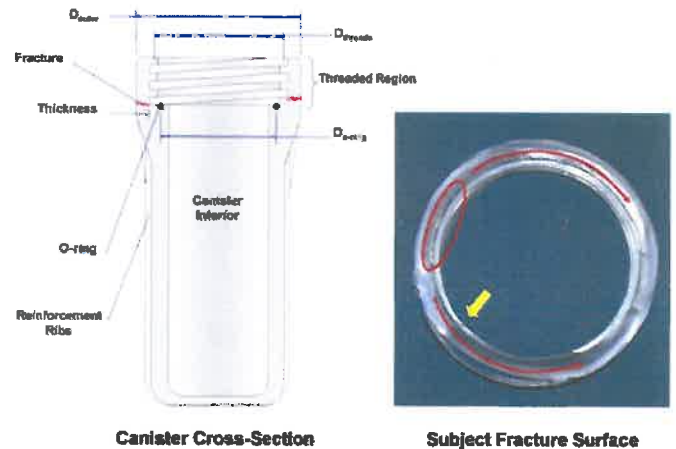
Figure 9: View of the clear plastic canister cross-section and subject fracture surface

A view of the clear plastic canister cross section schematic and view of the fracture surface is seen in Figure 9. The red line at the top of the cross section on the left, represents the fracture location. Features known as “beach marks” were observed on the fracture surface, which is indicative of a fatigue failure process. The red circle on the fracture surface on the right identified the failure origin – an unusual surface feature from which the beach marks seemed to emanate.

The operation of the high-pressure pump exposes the overhanging canister to additional loading due to vibration, particularly during machine startup. The cyclic vibration loading is consistent with the periodic striations observed on the fracture surface of the canister.

The fracture surface gave the appearance of fatigue striations on the canister fracture surface. The vibration loading induced onto the canister was quantified.

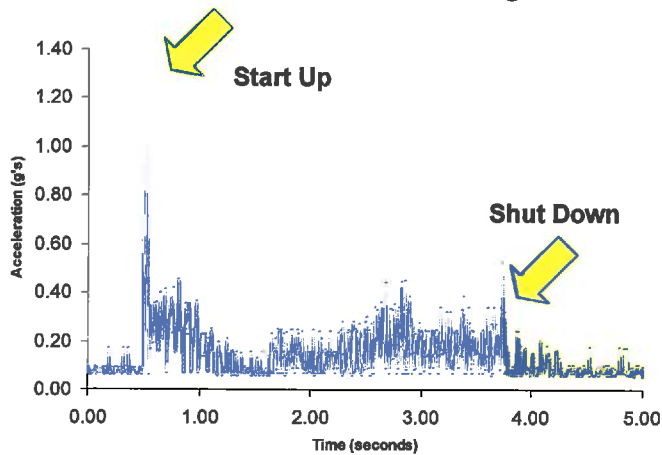
Figure 10: Acceleration data resultant (x, y, z axes combined) from Test04.

Figure 10 shows a resultant calculated data trace of the vibration information collected in test number 4. Test 4 had the highest measured vibration peak, at 1.3 g's. Whereas steady state vibration accelerations measured between 0.2 to 0.4 g's for each of the tests. As seen in the figure, the start up cycle produces the largest vibration peaks.

Vector resultant of the accelerometer traces provides the magnitude of g loading and its directionality. The predominant peak vibration orientation was along the Y-axis. This direction of vibration is parallel to the orientation of the pistons within the pump.

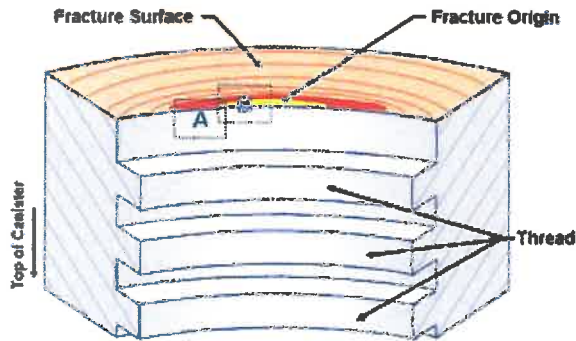
Figure 11: Diagram of SEM sample Section #2 and fracture surface features.

A diagram of Section #2 is shown in Figure 11. The diagram illustrates general part geometry examined and the relative locations of fracture surface features and SEM imaging.

The diagram represents a view the interior/threaded portion of the canister section examined. The fracture surface of this section features a brittle failure area identified by the yellow and red filled ellipses and is the failure origin. Emanating from the origin are bands or striations indicative of fatigue crack propagation.

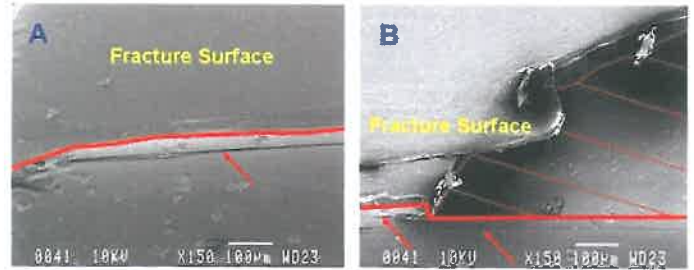
Figure 12: SEM images results.

Figure 12 is inverted from a canister's typical installation position. The fracture origin is located in a typical failure region, at the lowest loaded thread root (stress riser). However as detailed in the previous report, the geometry and material selection were appropriate for this canister design. Also, the applied loading was well within the canister's strength capabilities and should not have resulted in fatigue failure.

Figure 12 shows two of the SEM images recorded during the examination. The relative locations where these two images were taken are illustrated by the boxed A and B in Figure 11.

Both Figure 12 images were taken at a similar viewing angle as Figure 11. The thick solid red line highlights the corner of the examined part. Above the thick red line is the horizontal fracture surface. Below the thick red line is the vertical face of the thread root.

Figure 12A is an image taken near the outer edge of the brittle fracture region. The red arrow in Figure 12A shows a crack formation that is parallel to and just below the fracture surface, indicating a secondary layer of separation.

Figure 12B is an image taken closer to the center of the fracture origin area. Again the thick red line indicates the transition between the horizontal surface of the fracture and the vertical face of the thread root. The red line hatched region in Figure 12B indicates a lower elevation from the primary fracture surface. The two surfaces are parallel to one another. In fact, a closer examination of the step up region between them appeared to show the lower surface continuing to extend beneath and parallel to upper fracture surface.

The red arrows in Figure 12B show very straight grooves on the vertical face of the thread root that are parallel to the flat fracture surfaces in this region. Following the bottommost groove to the left, it eventually becomes the crack observed in Figure 12A (red arrow).

The parallel layering of the canister material in the region of the failure origin implies a lack of bonding between these layers. Un-bonded layers of SAN or any material will significantly reduce a part's overall effective strength. A weakness in the threaded region of the subject part is consistent with the findings before destructive testing and the failure is congruent with a manufacturing defect.
