Forensic Engineering Investigation of Basketball Goal Support Failure

David S. KOMM, P.E., C.F.E.I.; Quent AUGSPURGER, P.E.; Hugh J. MCSPADDEN

Augspurger Komm Engineering, Inc., 3315 E Wier Ave., Phoenix, Arizona 85040, USA

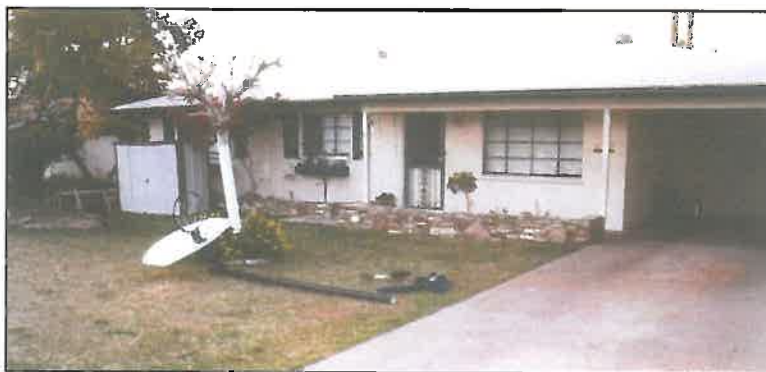
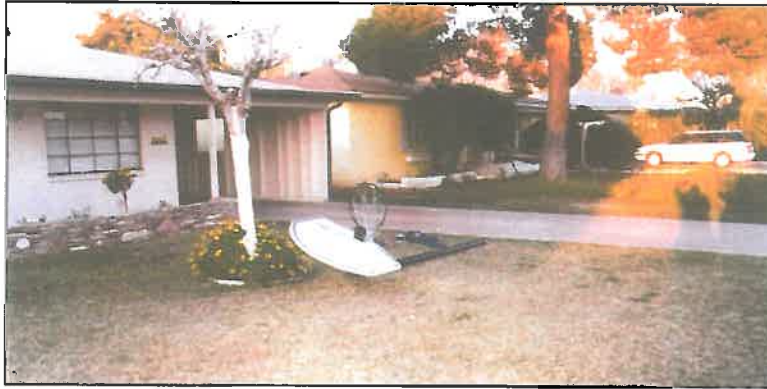
The position of the broken pole with reference to the house, yard and driveway is shown below in Photos 1a² and 1b².

Photo 1a². Broken pole in yard.

Photo 1b^[2]. Broken pole in yard.

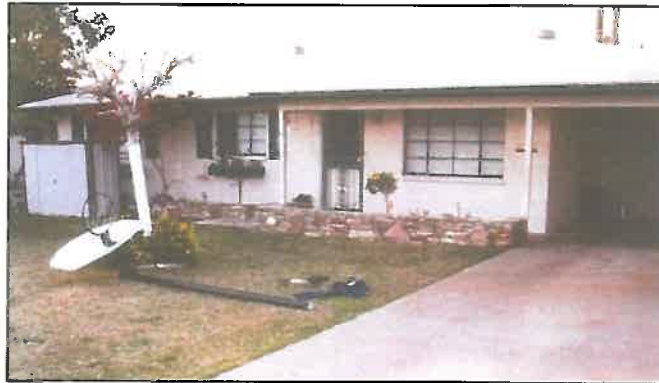
Photos^[2] taken on the day of the accident show the location of the fallen pole. The photos also show significant corrosion of the pole extending a few inches above the break, as well as the concrete filling the inside of the pole and the fact that it failed in a brittle manner.

Photo 1c^[2]. Location Of Fallen Pole

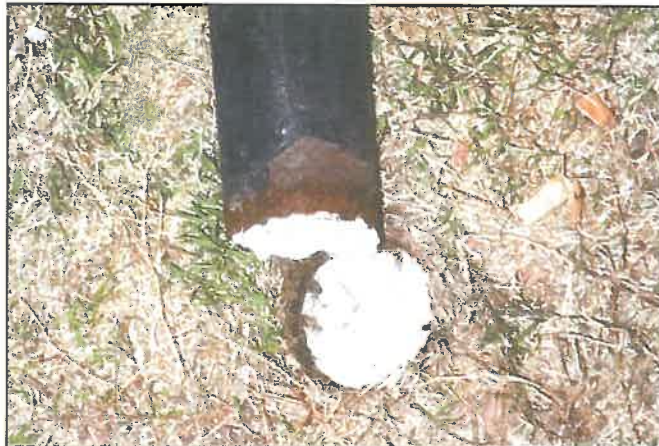
Photo 1d^[2]. Close-up Of Broken Pole, At The Break.

Close visual examination of the broken end of the subject pole was done, and showed the presence of the unreinforced concrete, as well as obvious thinning of the tube wall by corrosion (rusting).

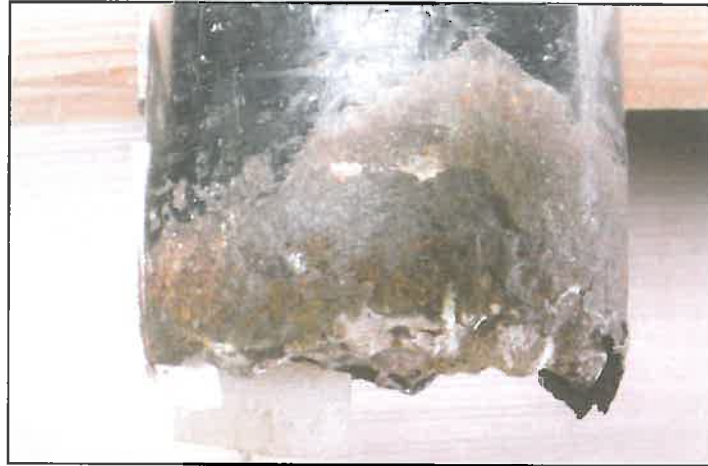
A sample of the metal of the subject pole was submitted to a testing laboratory for analysis. The results^[3] confirmed the metal is mild steel, ASTM alloy 1008.

Photo 2. Close-up View Of Subject Pole End, Showing Corrosion.

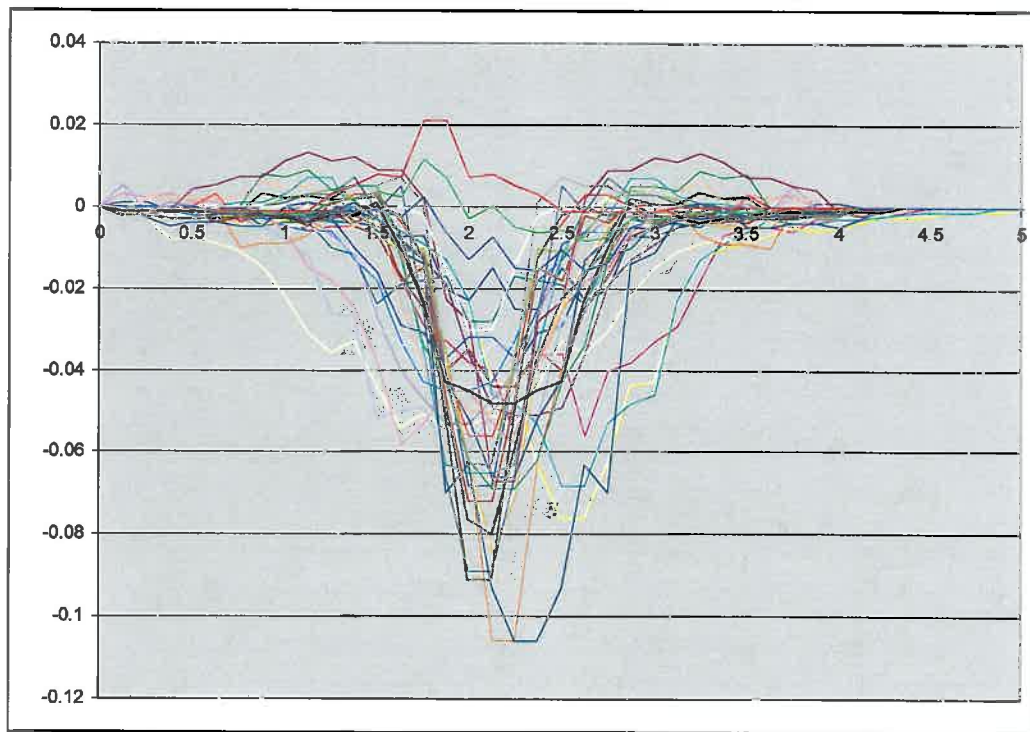
Measurement of the corroded portion of the subject pole was done in a pattern of every 0.125 inch axially, and every ten degrees circumferentially. Measurements began at a point approximately 2.5 inches from the uneven edge of the failed pole.

Figure 1. Plot Of Initial Measurements Of Missing Metal Of Pole.

Analysis of the raw data showed a sinusoidal variation of the remaining steel thickness. After allowing for rust on one or both surfaces of the tube as appropriate, the thickness of the remaining steel was calculated to be 0.004 to 0.034 inches. The following graph shows the change in wall thickness, as measured on the subject pole. The measurements have been “mirrored” to provide a probable profile above and below the break. The measurements clearly show a “necking” effect as well as the off-center (sinusoidal) variation of the remaining wall thickness

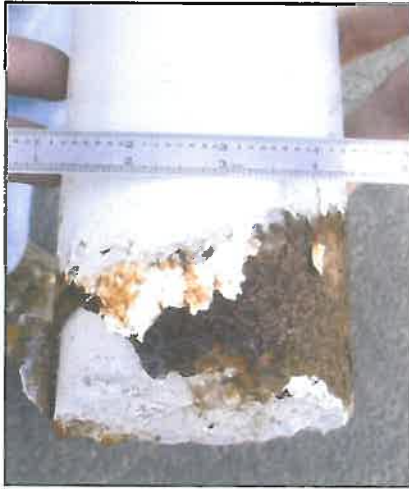
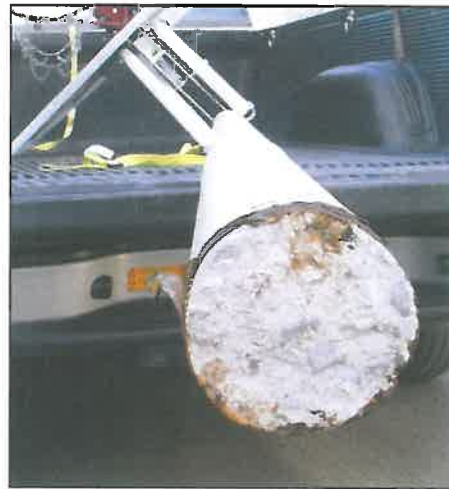
Photos 3a and 3b. Close-ups Of Exemplar Pole

The corrosion noted on this exemplar pole is very similar to that of the subject pole, and the pole metal was weakened enough that a portion of the tube wall offered little resistance to bending and possibly even tearing during the removal of the pole. In addition, the rust found on the broken surface of the concrete is evidence that the concrete was at least partially broken, if not totally broken before the pole was removed by Augspurgen Komm Engineering, Inc.. The rust also suggest the possibility that the pole had corroded all the way through in places. The broken end of the pole was located flush with the concrete footing.

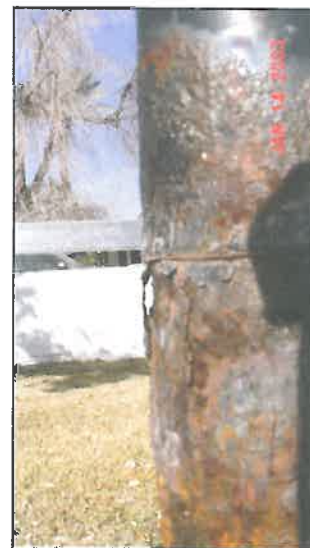
Photo 4b. Layers of Rust, Pushed Away From Pole Metal At The Joint Between The Lower And Middle Sections Of The Pole

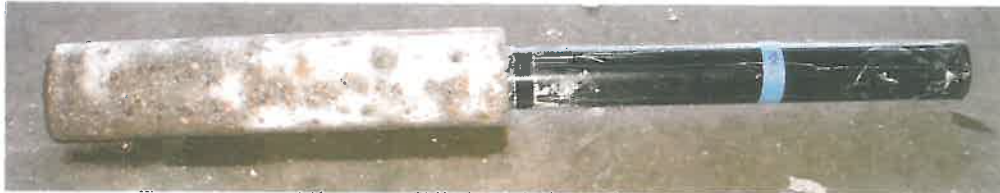
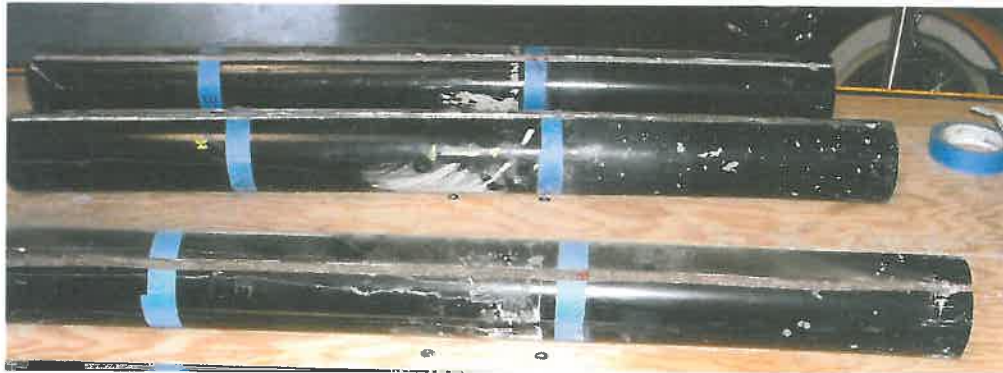
Photo 5a. Pole Section After Vibration, And Removal From Concrete Base.

Photo 5b. Pole Sections After Longitudinal Cutting, But Before Opening The Sections.

Photo 5c. Concrete From Pole Sections, Reassembled After Inspection.

Visual inspection confirmed all three concrete fillings were broken at a point corresponding to the depth of the outer concrete base. The concrete from each tube was in two pieces, with no bonding between the sections.

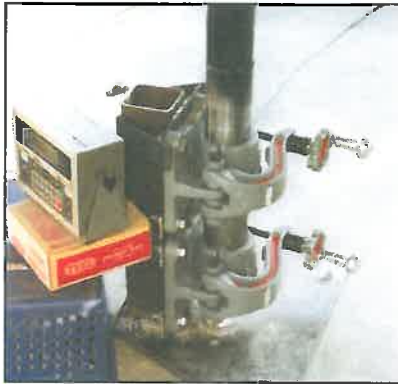
Photo 6a. Machined Exemplar Pole In Clamp, Prior To Test.

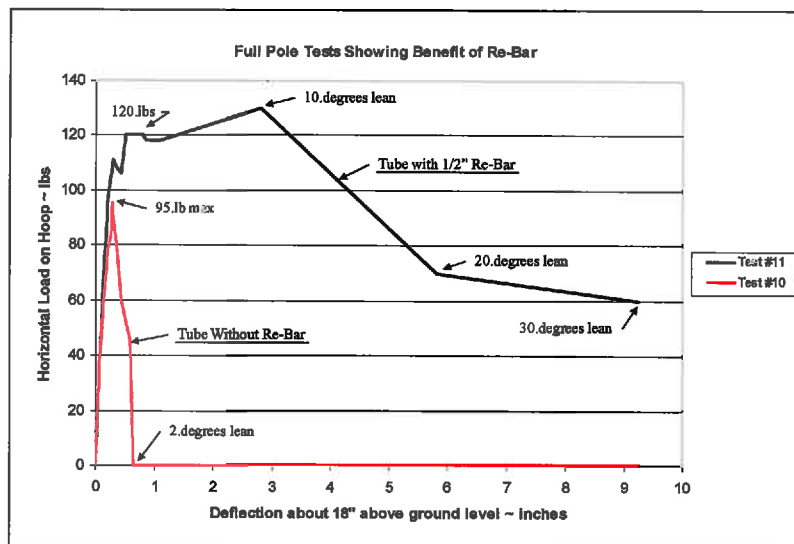
Two poles were tested for angular displacement prior to failure. One pole contained unreinforced concrete, and the other pole contained concrete reinforced with a 0.5-inch diameter steel reinforcing bar. The angular displacement was measured by a dial micrometer, and the degrees of bend calculated at intervals during the destructive testing. The testing was done by applying a tension load to the hoop of the goal until failure occurred.

Figure 3. Applied Forces, Versus Inches Of Lean Of Pole

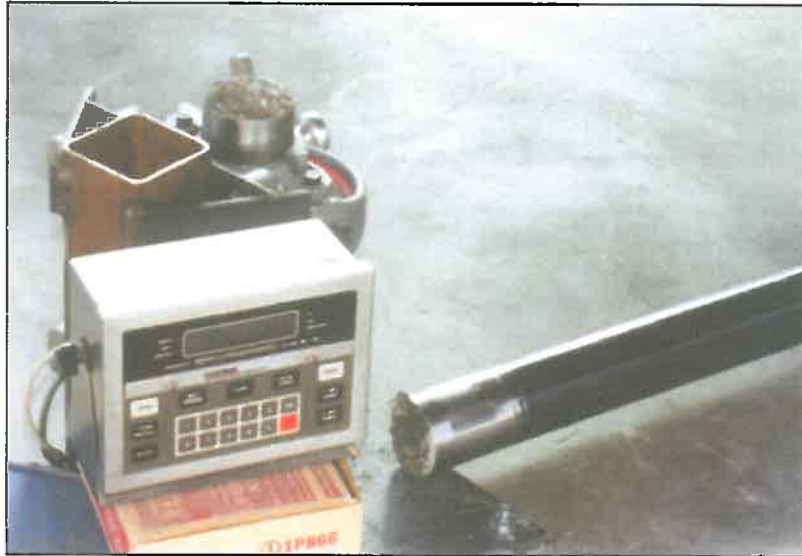
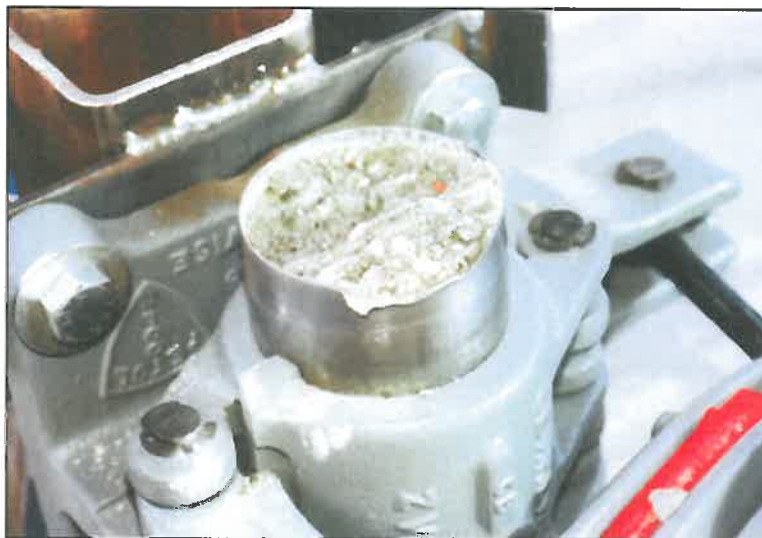
Tensile force was progressively applied to the hoop of the goal. Measurement of the force required was made with a strain gage load cell, monitored during the application of the tension tests. Failure occurred at the thinnest part of the machined section of the pole and the concrete broke with no reinforcing bar present in the concrete, shown in photos 6b and 6c.

Photo 6b. Machined Exemplar Pole Without Reinforcing Bar In Concrete, After Test.

Photo 6c. Close-up Of Failure Of Machined Exemplar Pole

Poles containing only concrete, without a reinforcing bar inside, failed abruptly and totally when subjected to bending tests that simulated the collapse of a corroded pole. The basketball goal assembly is top-heavy and once the steel failed, the concrete could not resist the bending forces. This failure occurred when the pole was deflected only a few degrees from the vertical.

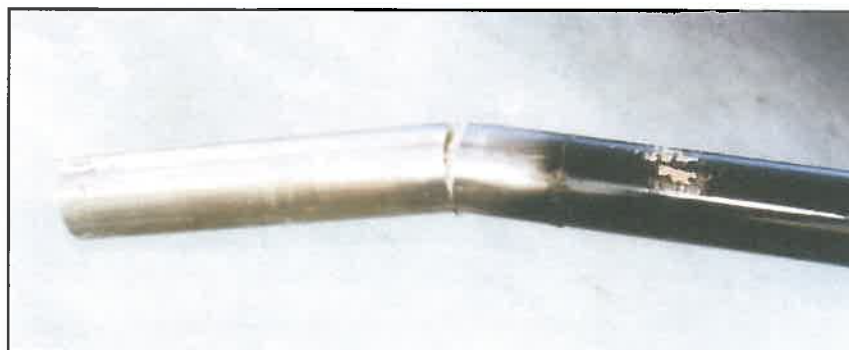
When a reinforcing bar was used in the concrete, the pole was bent and broken, with the concrete also broken. But the reinforcing bar provided significant strength, keeping the two portions of the pole together and thereby preventing a total collapse of the pole.

Photo 6d. Post-test Close-up Of The Exemplar Pole Containing The Reinforcing Bar In The Concrete.

In contrast, poles containing a reinforcing bar in the concrete filling did not fail in a catastrophic manner. The steel of the tube broke, but the pieces above and below the break remained connected, even when the upper portion was bent 30 degrees from the vertical.

Similar testing of an exemplar pole with the concrete containing a steel reinforcing bar clearly demonstrated the benefit of having the reinforcing bar: the metal pole was broken, the concrete was fractured, but the two portions of the pole remained connected to each other. The basketball goal assembly did not fall to the ground, even when the angle of bending clearly exceeded the angle required to cause failure in the exemplar pole without the reinforcing bar.

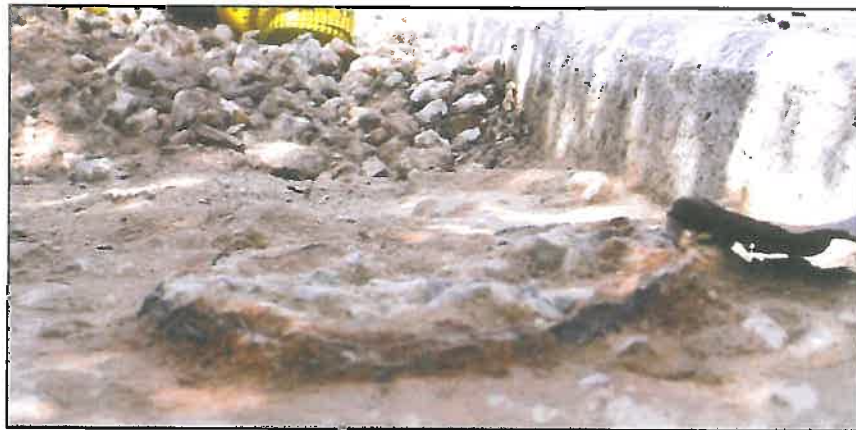
Additional pole installations were inspected, and all displayed similar patterns of corrosion: either adjacent to, or up to a few inches above, the top surface of the concrete anchor.

Installations inspected showed little or no drainage slope to the top surface of the concrete, and in some cases were uneven, indicating a lack of smoothing of the concrete during the installation. These and other factors increased the likelihood water would collect at the base of the pole, and potentially carry corrosive minerals to the pole.

Photo 7a. Corroded Pole Stub In Desert Landscaping

Photo 7b. Close-up Of Corroded Pole Stub In Desert Landscaping
