## Non Destructive Examination of Plastics Failures

### Typical Failure – Why, Where, and How

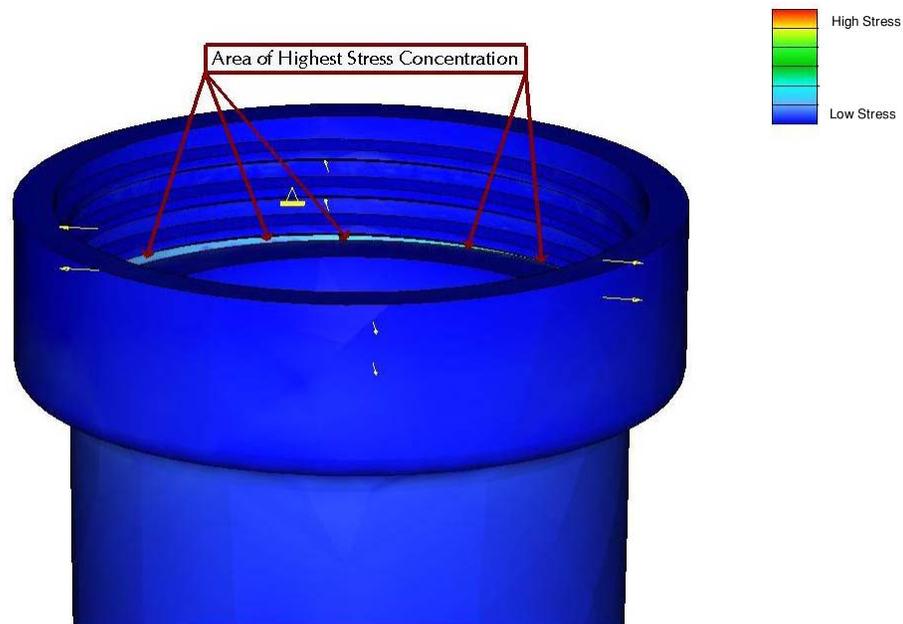
A recently completed water loss claim had a water canister which suffered a fracture, causing significant damage to a local business. Our findings were that the subject fracture occurred along one of the threads used to secure and mount the canister to the bonnet. This is a typical failure location in threaded components as it is this thread root that carries the highest stresses in the part. Stresses are concentrated in this region because of sharp geometry changes, known as stress risers, and a reduced cross-sectional thickness (the area is not as thick as that of a thread crest).

Figure 1 is a finite element model reflecting the highest stress region along the thread root:

The fracture was consistent with creep rupture, a typical failure mode in loaded plastic components. Over time, the stresses below the yield strength of the material relax the polymer chains, reducing the ultimate strength of the canister. When the ultimate strength of the part is reduced to that of the applied stresses, the part fails.

In this instance, the failure did not travel about the entire circumference of the part. As the canister began to crack, stresses were relieved elsewhere in the part, resulting in the incomplete fracture observed.

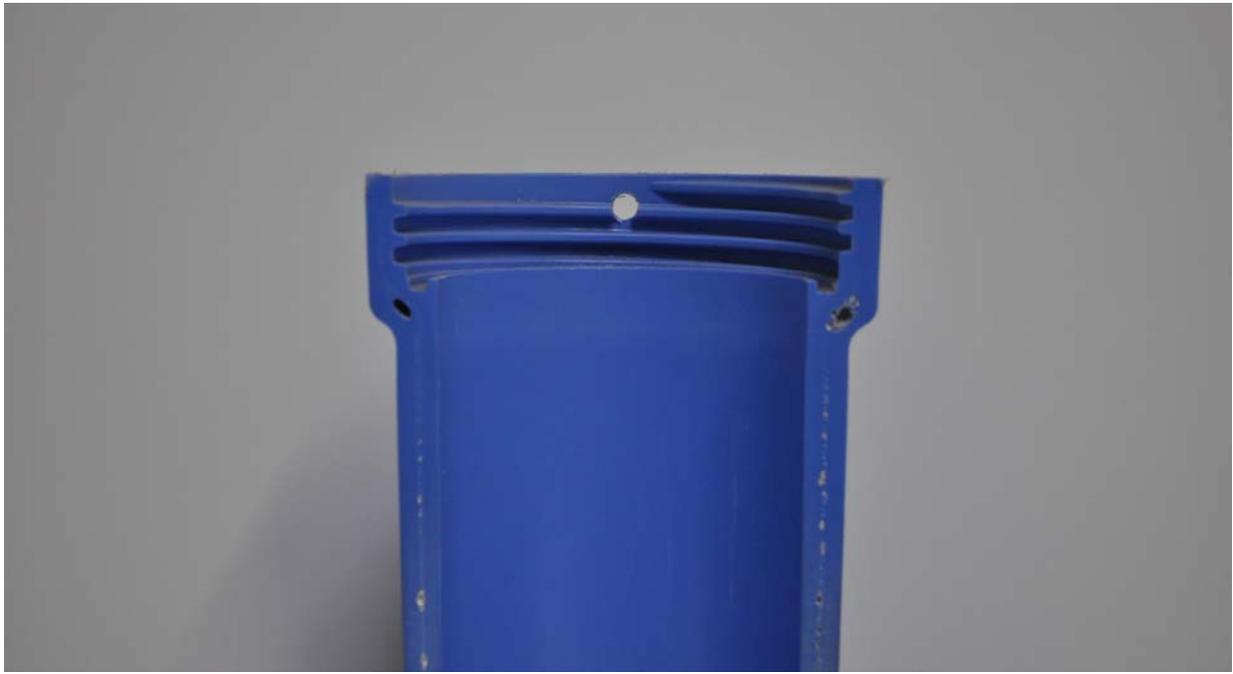
The subject canister had been in use for three years. Our experience suggests that canisters of this type which fail within five years are likely to have manufacturing defects, such as internal voids.

Figure 2 shows a cross section of a canister containing material voids as a result of poor manufacturing:

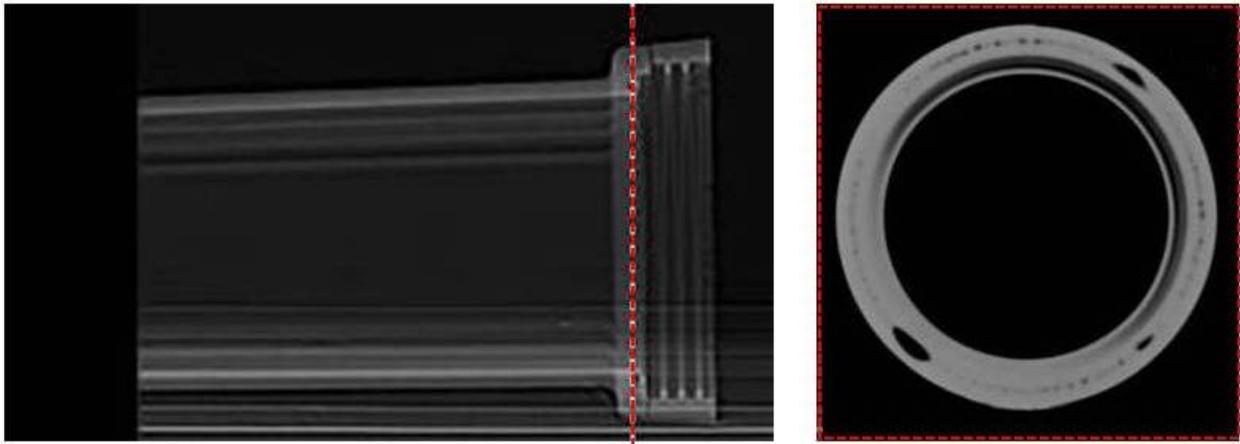
The image on the left side of Figure 3 is an X-ray profile view of a reverse osmosis canister. The set of red, dashed lines indicates the region scanned. Looking closely at this image it can be seen that the canister fracture is located just to the right of the red dashed line.

The image on the right side of Figure 3 shows an example image slice from the CAT scan data. The image slice shown corresponds to the red dashed line visible on the X-ray profile image. The CAT scan data showed the part is solid through its cross-section but contains areas of significant material voids.
