## NON-DESTRUCTIVE TESTING METHODS FOR EXAMINATION OF FAILED PLASTIC PARTS

Eric A. Beebe, E.I.T., Kevin W. Hollander, Ph.D., David S. Komm, P.E. and Todd A. Springer, E.I.T.  
Augsburger Komm Engineering, Inc.

### Abstract

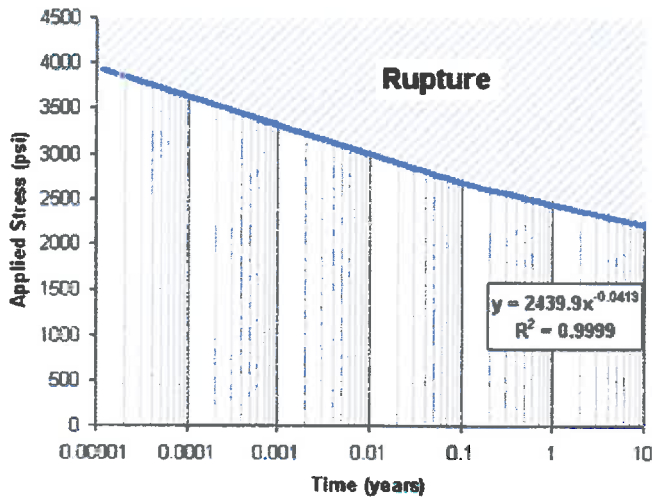
Figure 7: Tensile creep rupture for polypropylene, tested at 20°C (68°F)

Failure by creep rupture is dependant on several factors, such as applied stress, temperature and time. Figure 7 is graph showing the creep rupture threshold plotted in terms of applied stress and time, temperature was held constant. Using this figure, expected service life of the part can be estimated. This figure was adapted from data provide by Maier and Calafut (3).

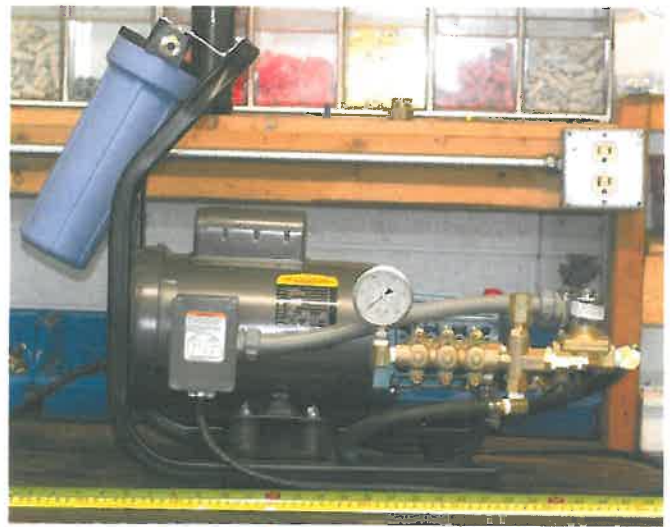
Figure 8 – Exemplar Misting System Pump Unit

We examined a clear plastic filter canister that was a component of a high pressure misting system. This canister was placed on a bracket and mounted to a misting system. The canister was mounted to a small flexible bracket that is oriented approximately 30 degrees out from a typical vertical orientation. Most filter canisters hang in a vertical orientation from their bonnet attachment. A view of an exemplar unit is shown in Figure 8.

It is known that both clear plastic and blue plastic filter canisters exist. The canister examined was a clear plastic canister.
