## Non Destructive Examination of Plastics Failures

### Typical Failure – Why, Where, and How

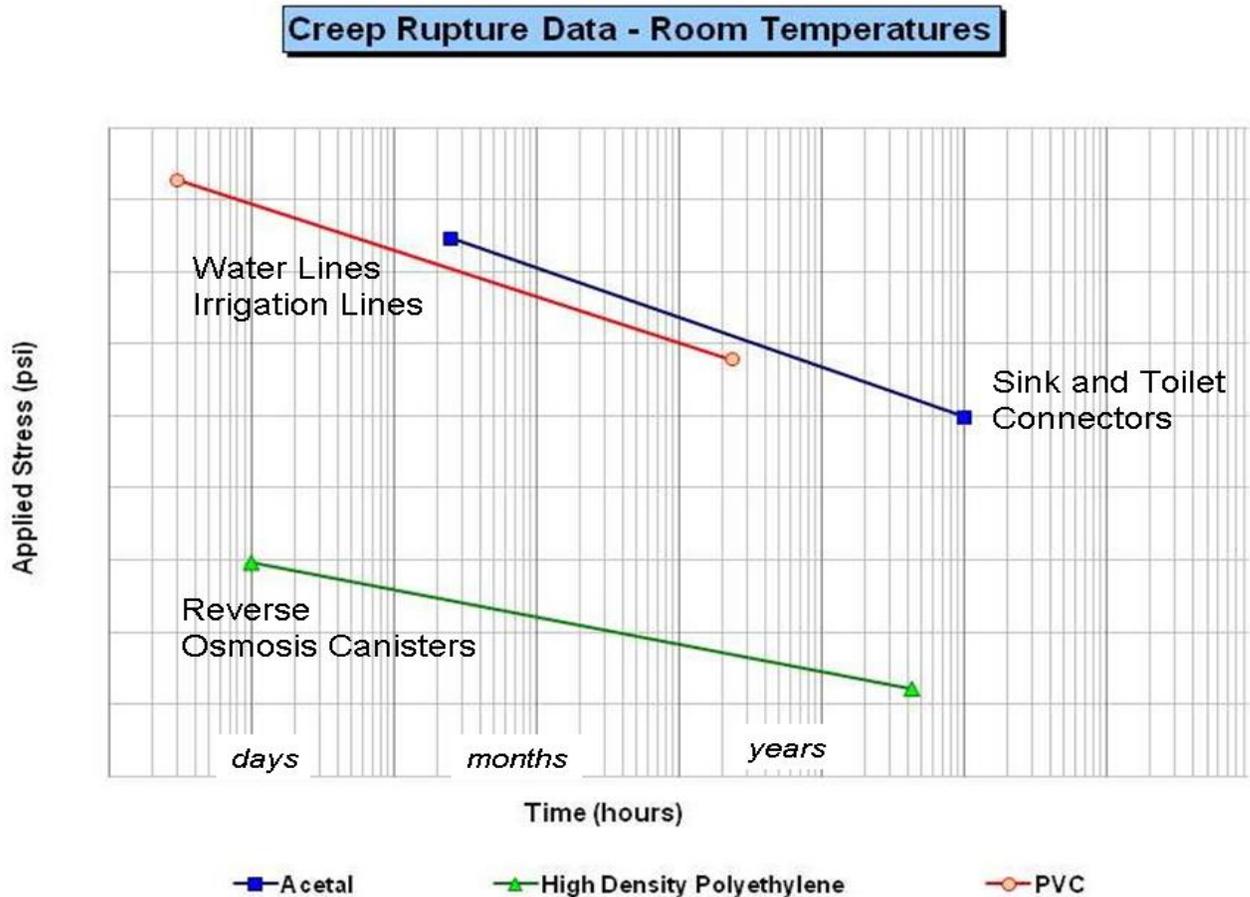
Creep life expectancies for some common materials can be seen in Figure 4. The logarithmic graph data contained in Figure 4 was calculated for average room temperatures. This information helps determine, under a certain amount of stress, such as water pressure, how long the part would likely last.
